CASE STUDY

Abandoned mineshafts located and filled

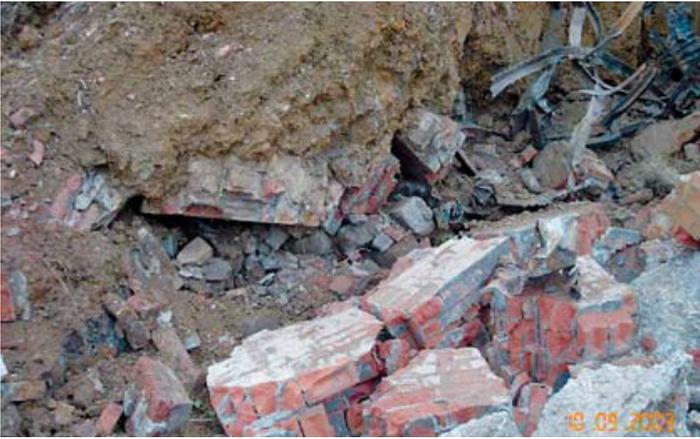
A probe drilling scheme was carried out to locate the mine entries. By combining all the relevant plans and information from various sources including Coal Authority mining reports, OS mapping, abandonment plans and previous site investigations, GRM were able to identify 13 possible locations within the development area.

At each possible location, probe holes were drilled and progressed to rockhead over a 10m x 10m area, the spacing of the grid having been determined by the anticipated shaft diameters.

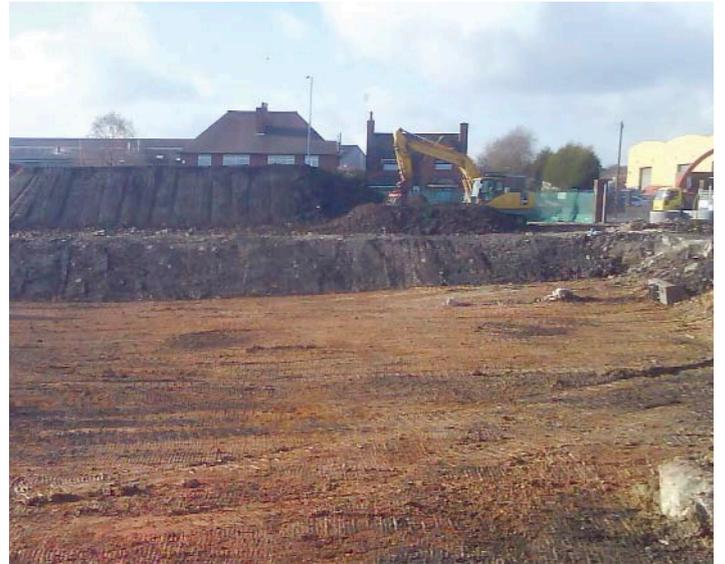
The four mineshafts that remained and posed a threat to the development were successfully drilled and grouted throughout their entire length. Boreholes were drilled to check that all the shafts had been successfully filled prior to the shafts being capped.
